INDEPENDENT INSPECTION & REPORT

STANDING SEAM ROOF

CHIPPING NORTON LEISURE CENTRE BURFORD ROAD CHIPPING NORTON OX7 5DY

22nd December 2022

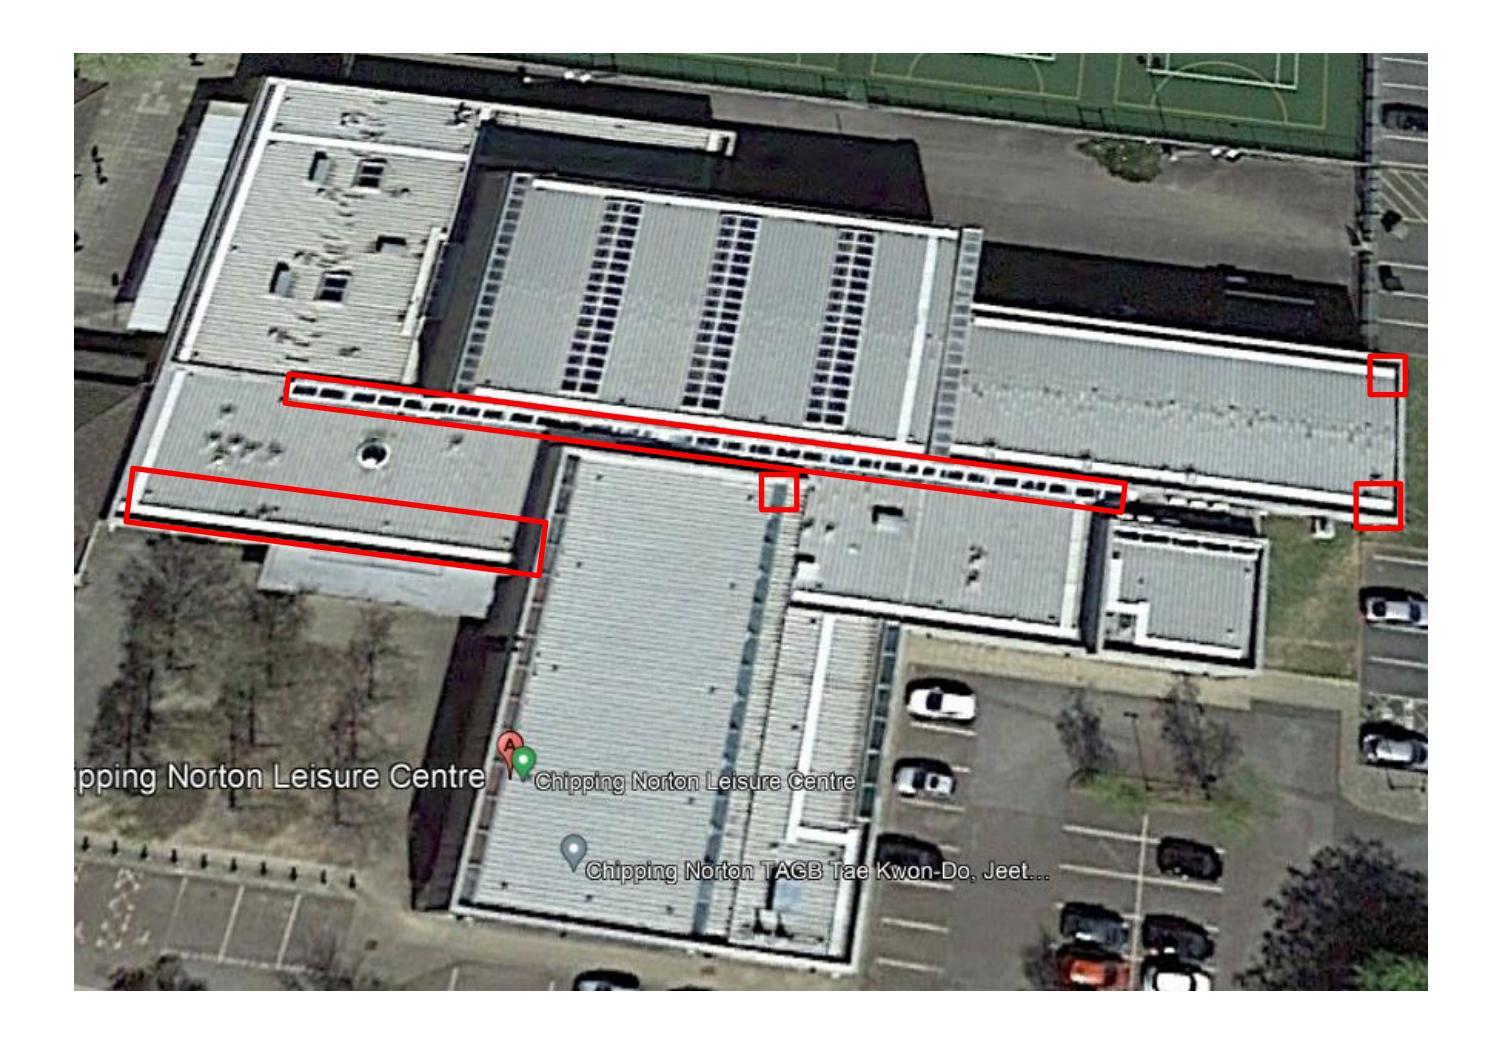
4.1 Long term water ingress was reported to me by the centre mangers as occurring in the areas highlighted on the image below.

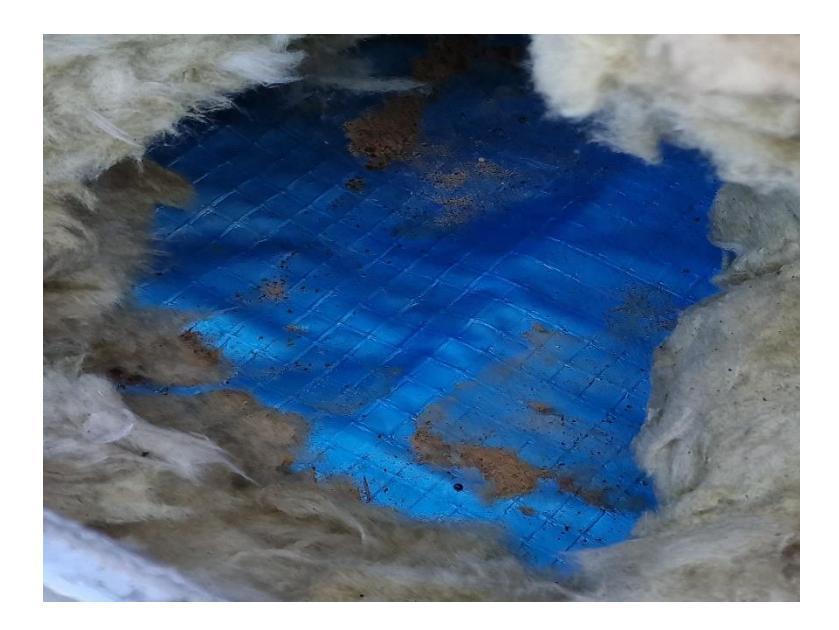
BEMO vapour control layer in place, but I could not inspect the sealing of end and side laps

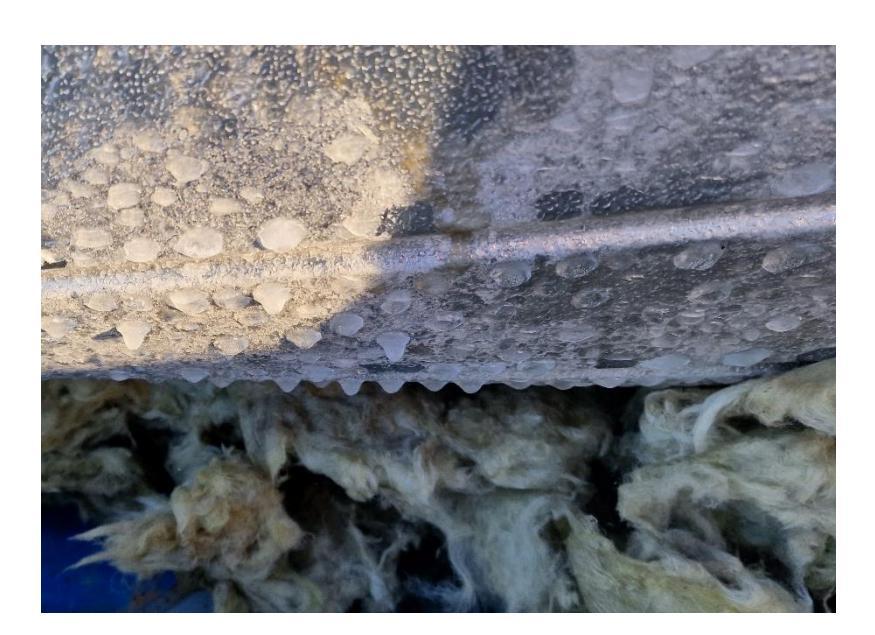
4.2 On the underside of the aluminium roof sheets we identified the presence of condensation which at the time of my inspection was frozen. It's not unusual to find an element of condensation on the underside of metal roofs but this ordinarily vents out through seams etc, however in this case the quantity of moisture did appear quite high, although this may be due to the current exceptionally cold weather conditions.

Condensation build up on underside of aluminium roof sheets

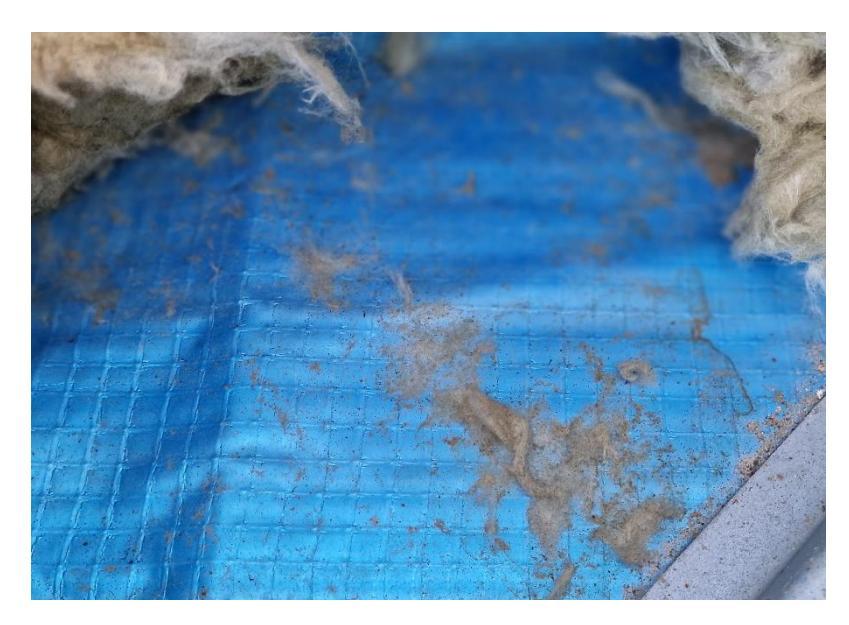
Water staining on VCL surface

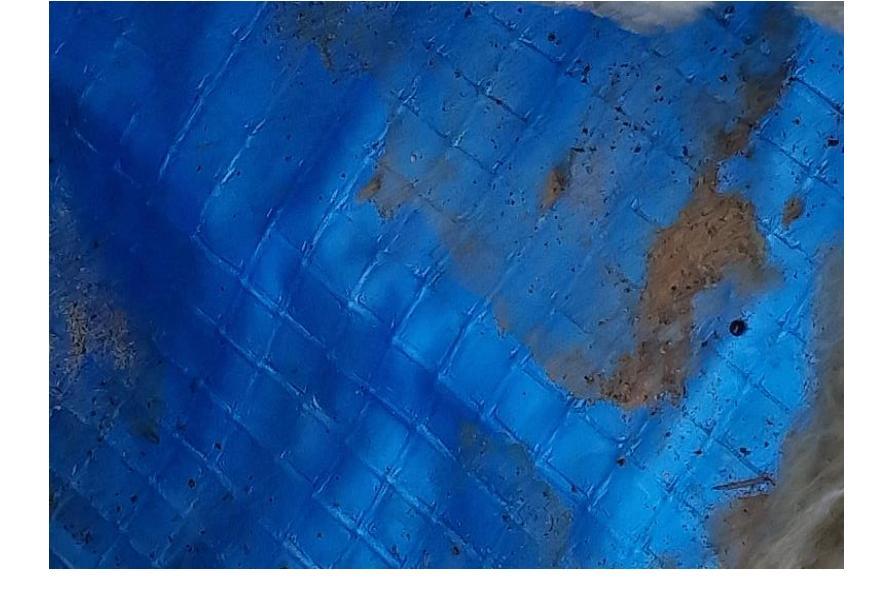
Water staining on VCL

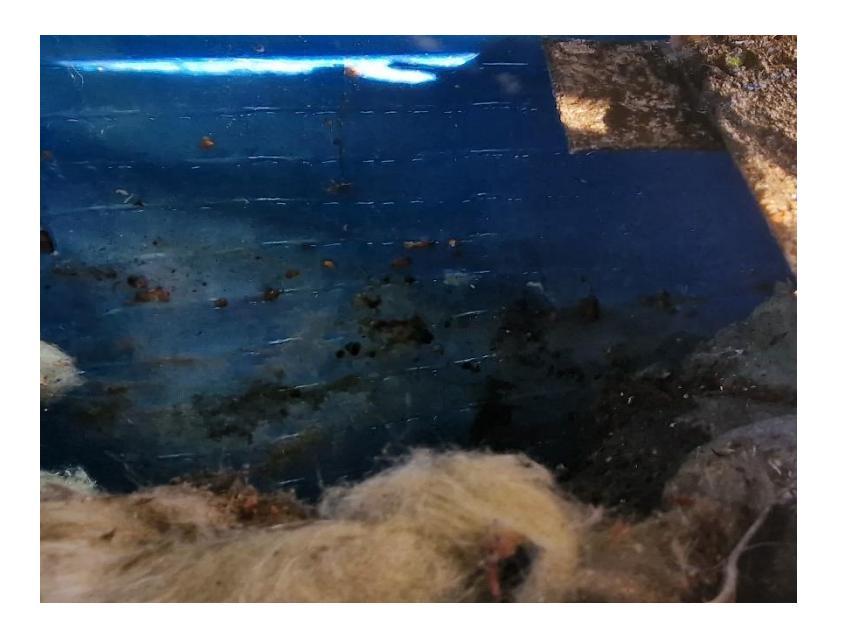
Water staining on VCL where it turns up at the roof lights

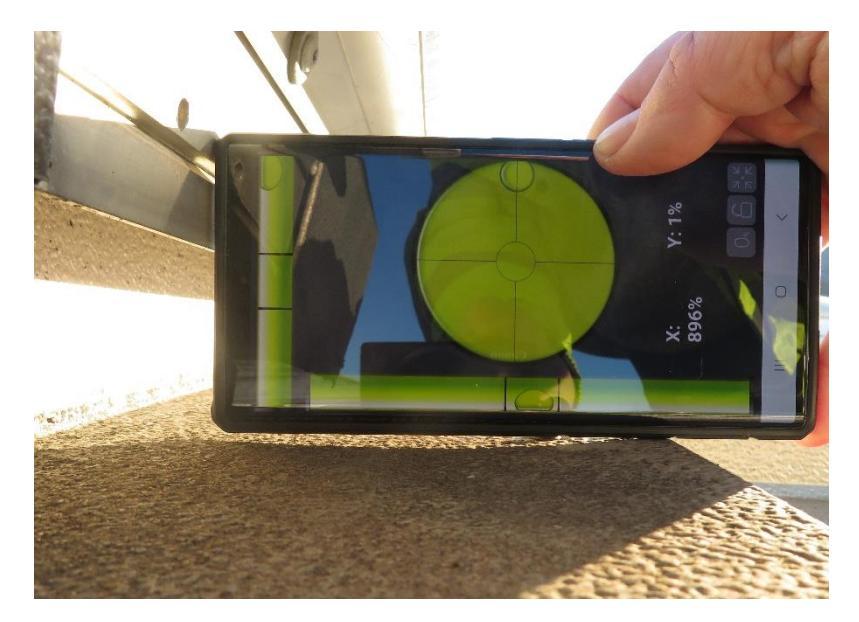
Back fall to roof light flashings will allow water to sit on the flashing rather than drain off it

- 5.05 The drip flashing along the length of the roof light has been installed with a back fall allowing water to pool along the back edge of the flashing. Where the butt joints have failed water will drain into two areas, either on to the VCL and drain down to the roof eaves leading to some of the mould and water ingress in the reception area, and staff rooms. The other area water from entering the building via the drip flashing to the roof lights is the corridor are immediately below the roof light.

| | Aluminium Cover Flashing to Rooflights | Qty |
|---|--|---|
| 9 | Carefully open butt joints to cover flashings weathering the roof lights to the roof and clean residual sealant off the butt straps and drip flashings and make ready to receive new butyl sealing strips. | 57m |
| 10 | Apply new butyl sealing strips to both sides of joint and re-rivet drip flashing. | 57m |
| 11 | Apply a reinforced liquid coating bandage (Triflex Pro-detail or equally approved) to the full girth of the drip flashing and 300mm wide (150mm either side of butt joint) | 57m |

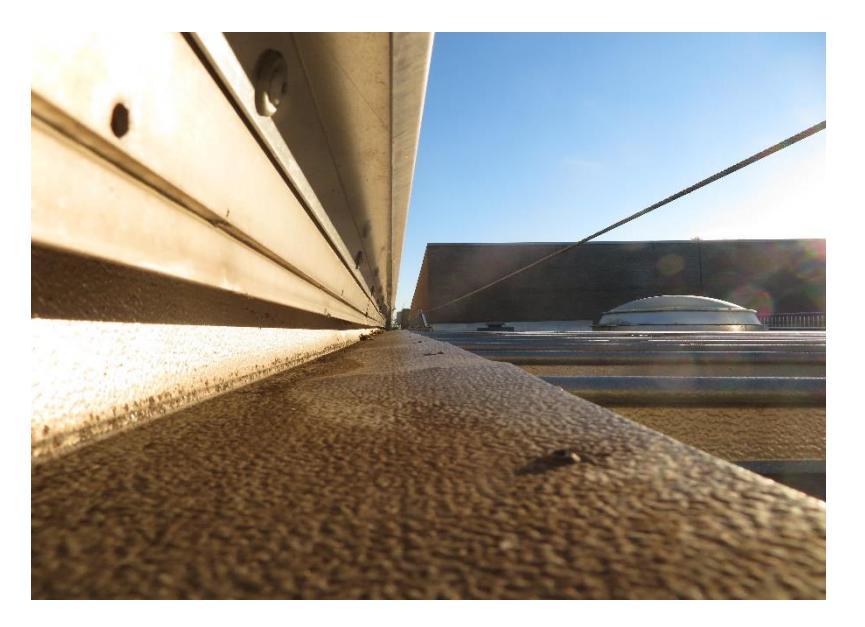
Water staining on flashing shows how the water sits along the back edge of the flashing

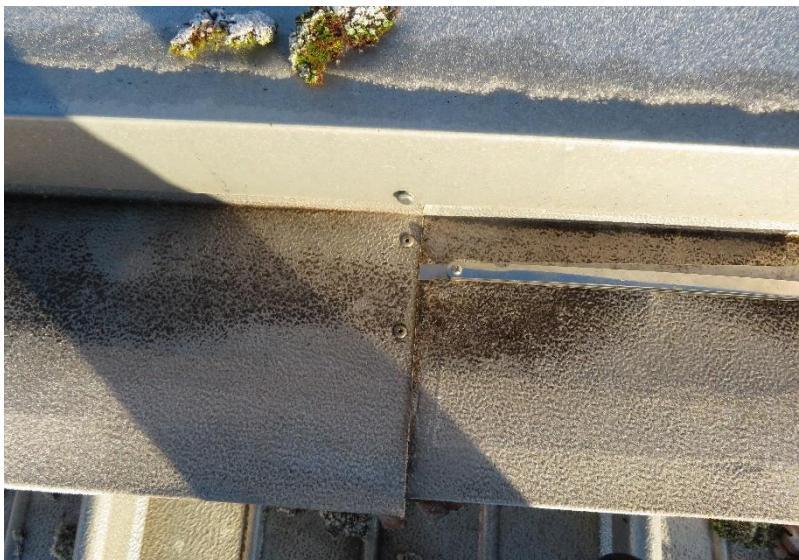
Where water pools over a flashing butt joint, if the seal is not 100% as in this case water will drain in tothe roof build up

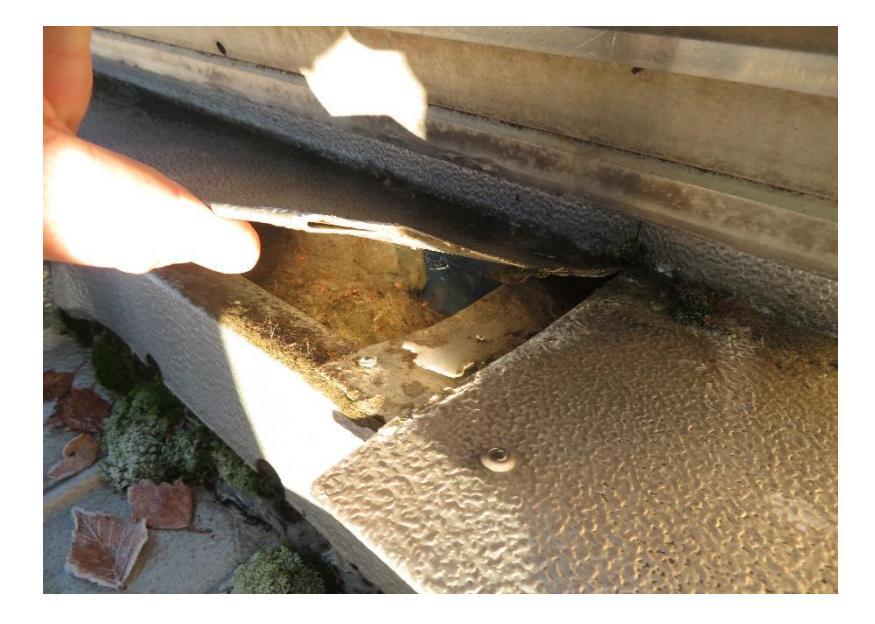
Butt joint completely failed when this was opened up the insulation was wet and staining on the VCL was visible

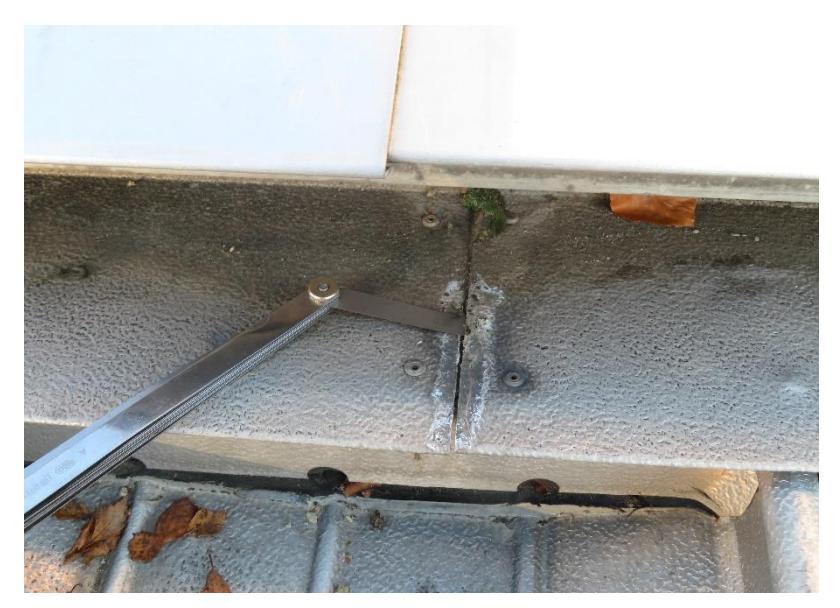
Further evidence of failed but joints in the drip flashings to the roof lights

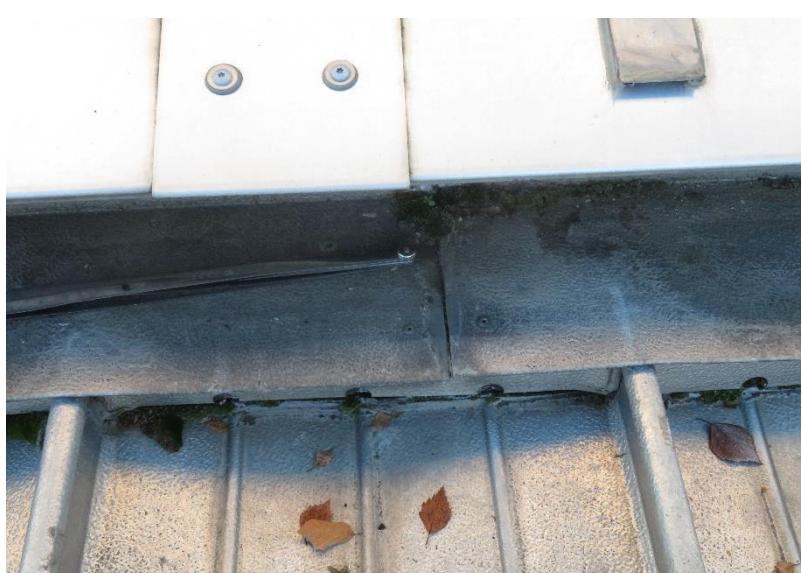
Ditto last

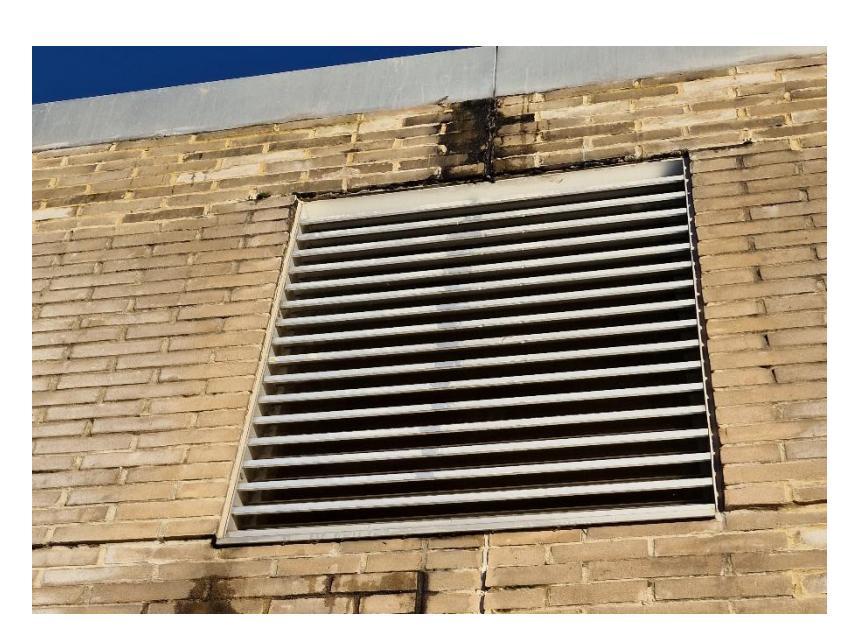
4.6 It was noted that there is water staining arising from a possible leaking gutter along the top of the wall to the sports hall area. Water from the gutter appears to be draining down the wall. The lead flashing directly below has not been correctly sealed leaving a possible route for water to enter the cavity wall below the level of the cavity tray, from where it could manifest as a leak int the building.

Water draining down wall from upper roof gutter, some of which could be entering the cavity at the head of the louver screen whilst the remainder drains down the louver and onto the wall below

12 Clean out eaves gutters to sports hall roof and prepare gutter for relining using a reinforced liquid coating (Triflex Pro-detail or equally approved) to full length of both runs of eaves gutters

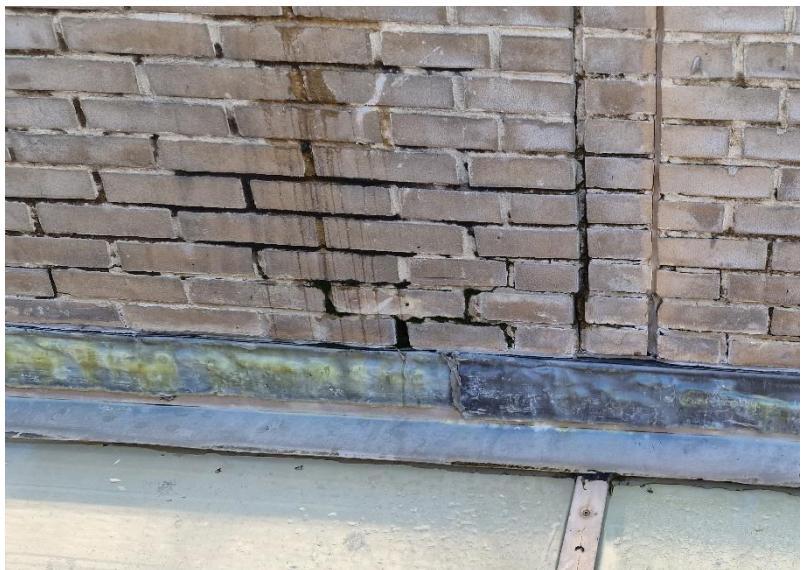
The water drains down onto the dpc and lead flashing

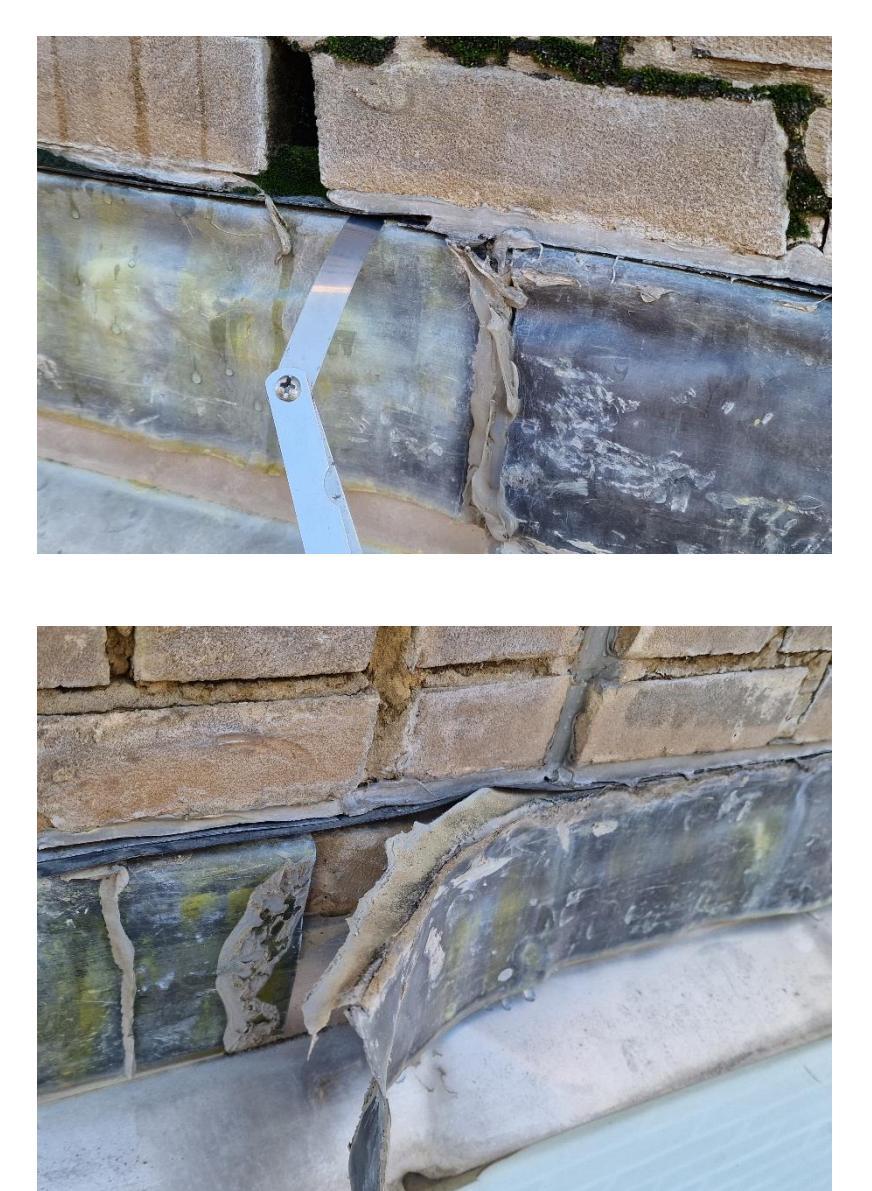
When the joint between the lead flashing and the DPC was probed it was possible to slide the probe into the cavity wall which will also be a possible water track into the cavity wall at a level below the DPC which could manifest as a leak in the building

Water staining could be seen on the top edge of the lead flashing where it is turned into the brickwork indicating the presence of moisture

- 5.06 Water ingress into the corridor could also be contributed to by the incorrect detailing of the cavity tray and lead flashing exacerbated by the poor detailing of the capping to the sports hall roof which is allowing water to drain down the wall directly above the lead flashing detail.

- 5 Carefully remove existing lead cover flashings weathering the roof lights to the brickwork and dispose of from site to the areas highlighted below
- 6 Carefully rebate the brick and below the dpc to create a chase 8mm chase immediately below the dpc, the new chase should be cut a minimum of 25mm into the brickwork creating a chase 8mm wide x 25mm deep.
- 7 Supply and fit new 150mm code 4 lead cover flashing in lengths N.E 46m 1500mm with a minimum of 100mm laps between pieces of lead. The new flashings should be dressed a minimum of 25mm into the newly created chase and wedged into position using lead wedges positioned at centres N.E 450mm.

8 Point lead flashing into chase using lead sealing mastic and make good 46m to any disturbed pointing above the existing dpc.

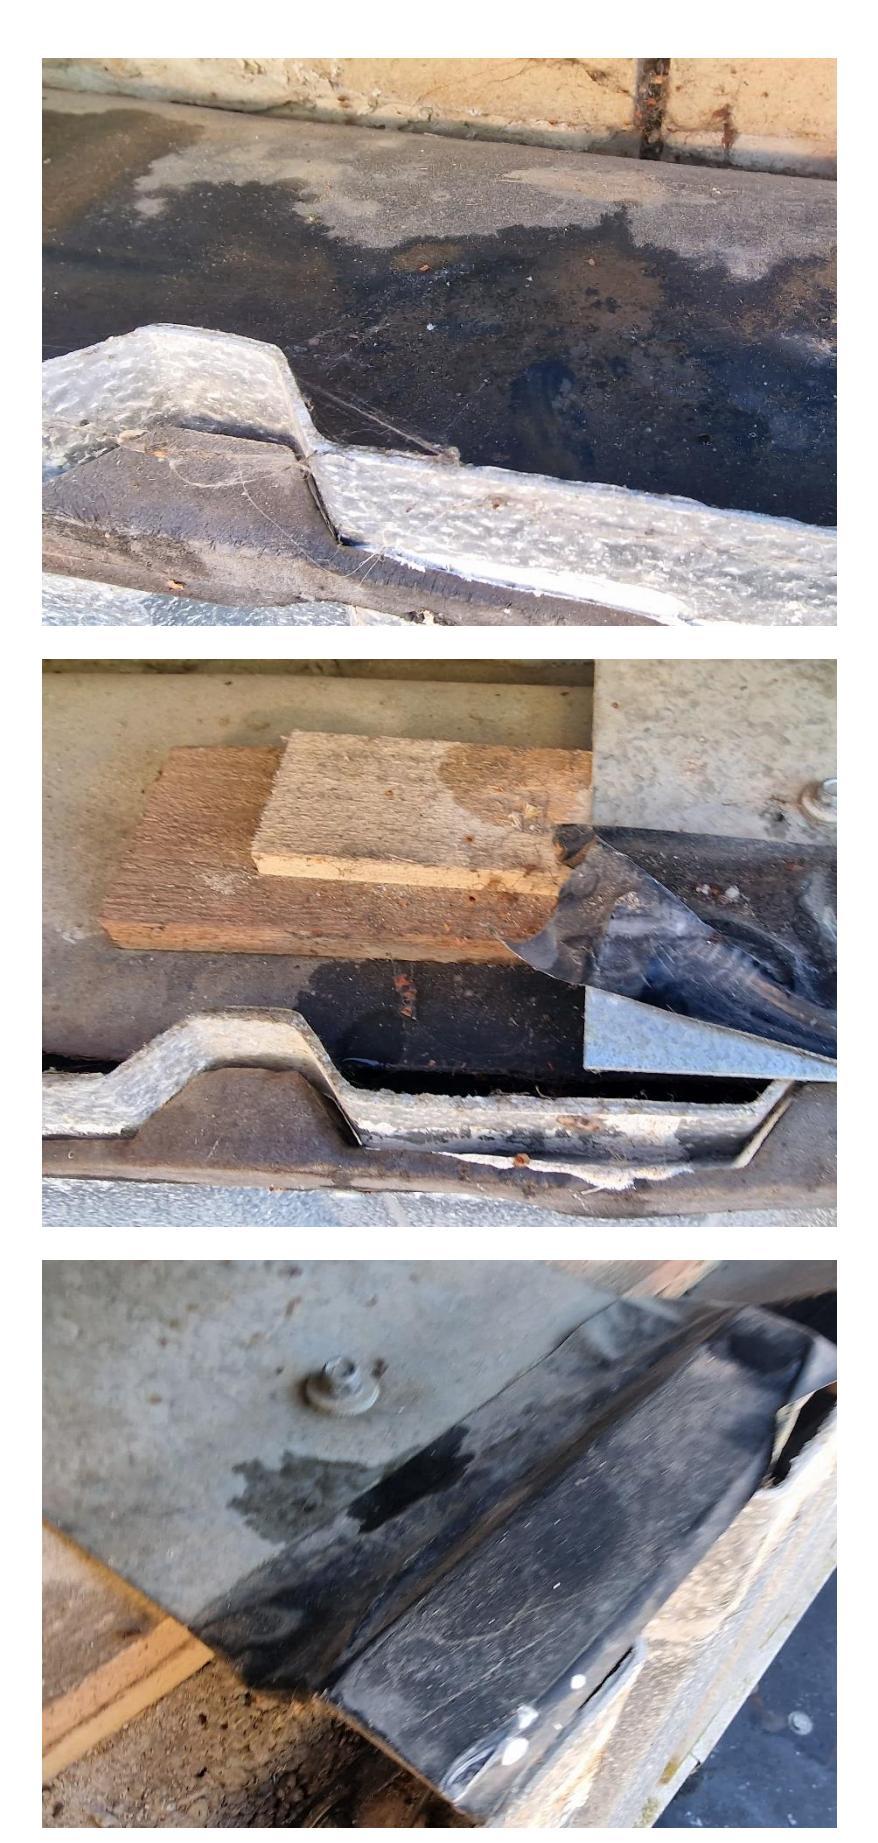
4.7 Where capping's were removed it can be confirmed that a dpc has been installed, however it is of insufficient width to protect the underlying cavity is allowing any water that gets onto it to drain into the cavity rather than draining to the outside. There was also evidence of not only fresh deposits of water in the cavity but also water staining.

Water was present on top of the cladding rails.

- 5.06 Water ingress via the poor detailing of the metal capping's and associated dpm/dpc below the capping's which appears to be allowing water to drain into the parapet wall build up, from where it could access the roof build-up adding further to water ingress being experienced in the reception area and also the gymnasium.

Aluminium Capping's Qty 1 Carefully remove existing aluminium capping's and dispose of from 72m site to the areas highlighted below 2 Cap off the existing cavity to parapet wall with 18mm marine grade 72m plywood allow for associated packings and timber bearers as necessary 3 Overlay marine plywood with foiled faced reinforced self-adhesive 72m bitumen membrane and dress onto external faces of parapet wall N.E 50mm 4 Supply and fit new once weathered Ali-fabs Architectural copping 72m system including all requisite concealed fixing straps and double jointing bracket complete with EPDM rubber seal, colour to be

system including all requisite concealed fixing straps and double jointing bracket complete with EPDM rubber seal, colour to be confirmed. Allow for all corners, upstands and stop ends tee junctions etc to be factory manufactured and **NOT** site fabricated. Allow for weathering new capping to existing and also weathering to brickwork

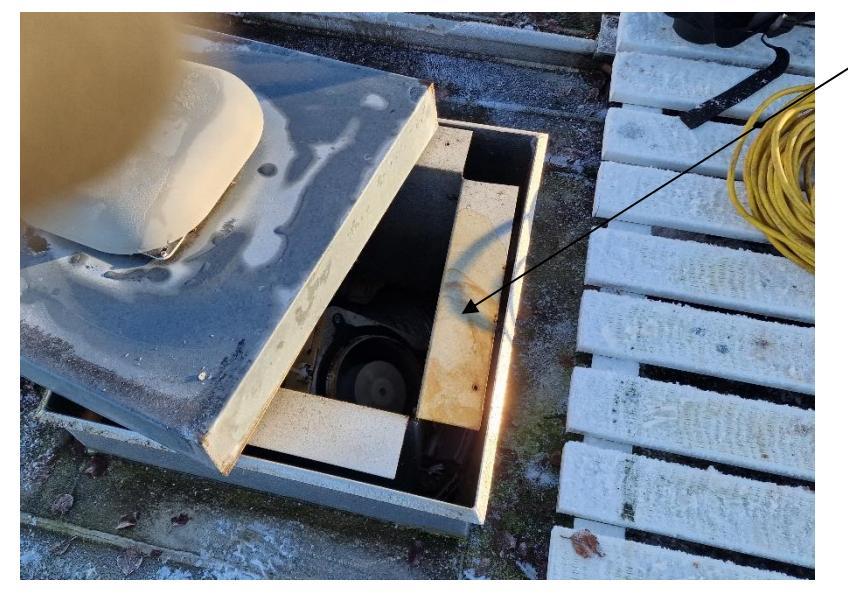
Note water staining to fixing bracket

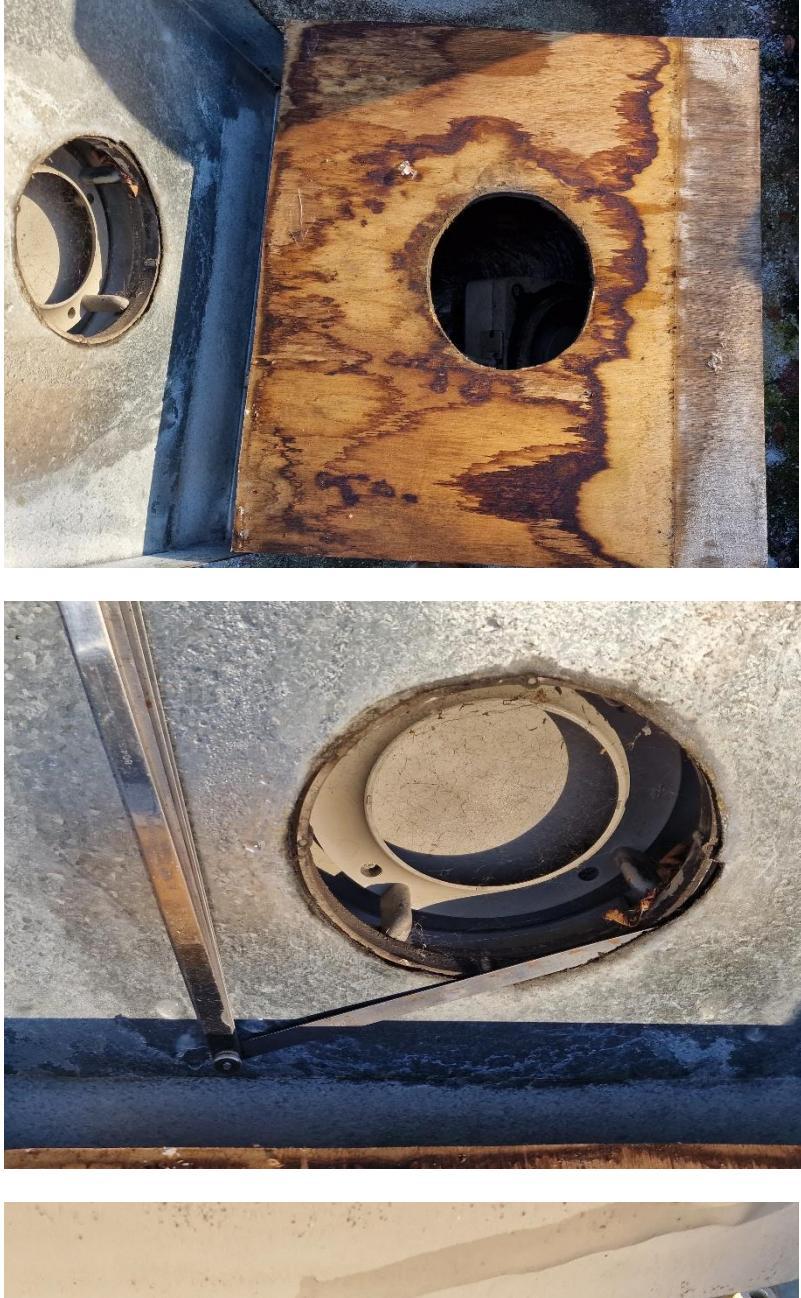
Water staining to plywood support under aluminium vent cap

The joint between plastic vent and aluminium vent cap is not effectively sealed

- 5.05 Another contributing cause of the mould in the reception area and staff room is leaks arising from the poorly sealed vent caps allow water into the roof build up.

- 13 Carefully disconnect ventilation ducts from ventilation cowls and remove existing ventilation caps complete and dispose of from site.
- 14 Supply and fix with new vent caps and cowls ensuring the cowls are fully sealed to the metal caps. Allow for re-connecting ventilation duct once installed.

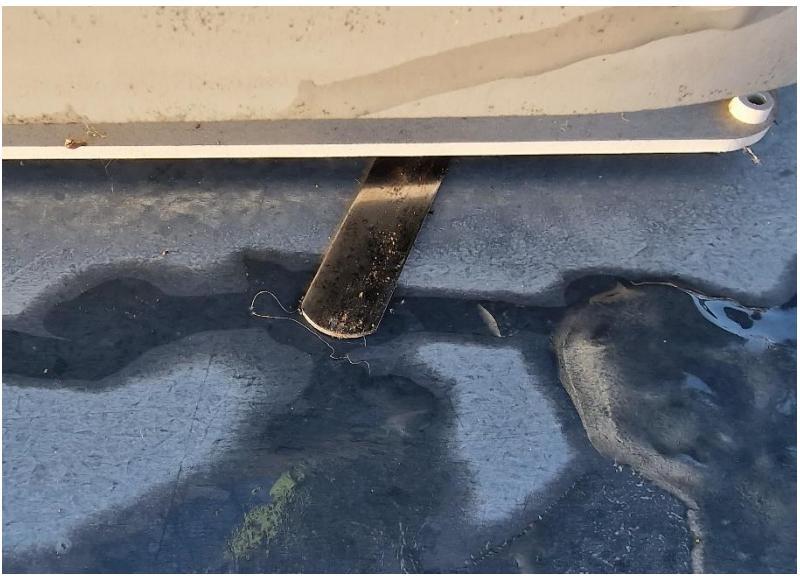
The joint between plastic vent and aluminium vent cap is not effectively sealed 4.10 At the time of my inspection the gutters were clear of any debris and I assume they had recently been cleaned out with no reports of the gutters being over whelmed, even during the recent heavy rains experienced in October/November of this year
